MEMORANDUM

Date 09 April 2015
Reference UA007705-19-ECV-MEM-HYD-1502 rev A01
From Toby Skeels
To Ian Grimes, Daniel Perez
Copies Richard Shimell, James Buckley, Tom Faith, Geoff Rowan
Subject Alton Station – Heritage Footbridge Condition Report

DEFECT RECORD PHOTO
PLAN - ALTON STATION
HERITAGE FOOTBRIDGE

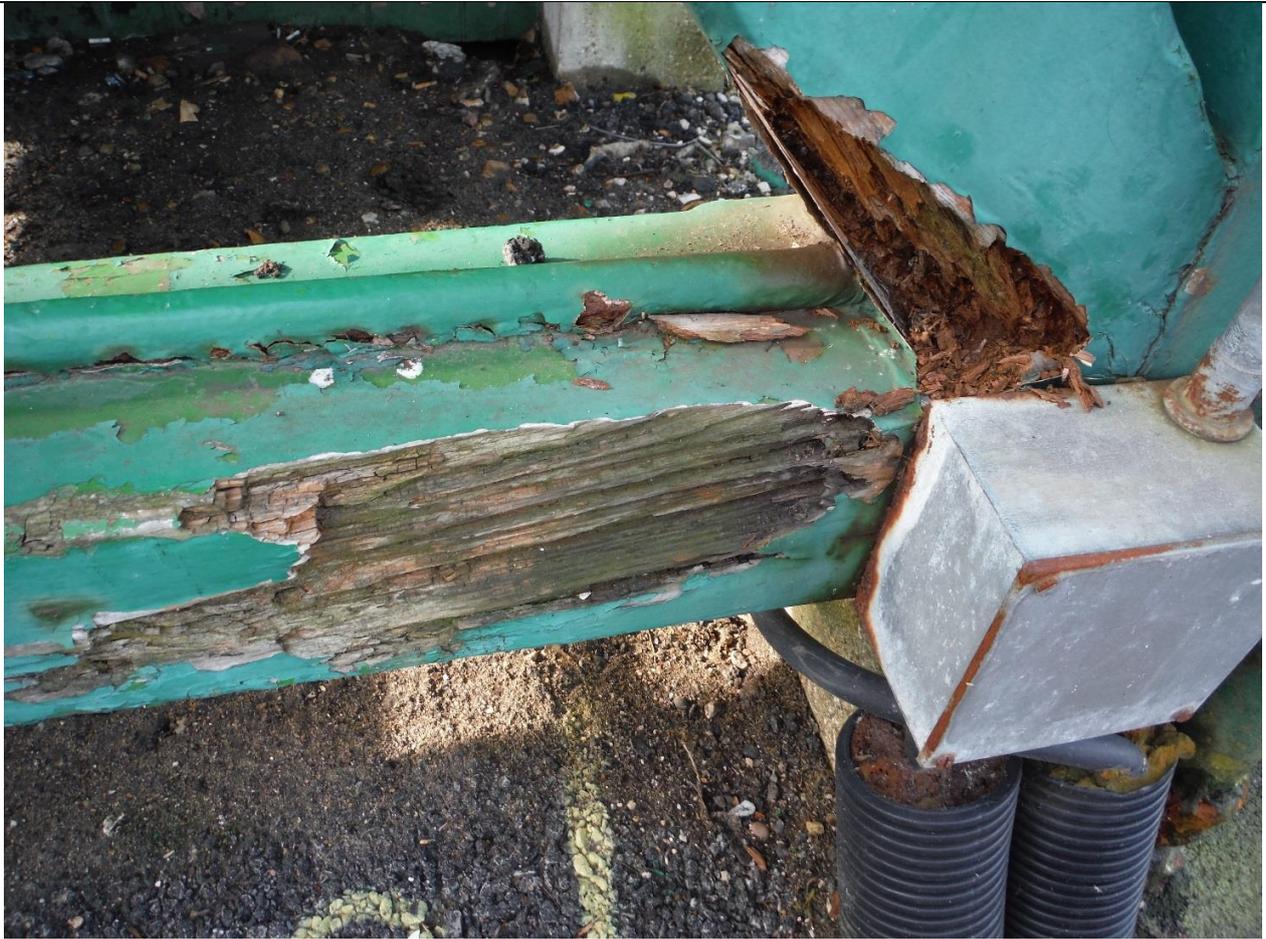
Photo 1: Wet rot to lower connection of 4 post support column diagonal brace (Platform 1)

Photo	Defect	Repair	Time frame for action
1	Wet rot causing loss of section	It is recommended that where rot (wet and dry) is present that specialist advice is sought to ensure appropriate remedial action is taken to agree a surface treatment is performed to prevent further section loss	3 Months
2	Dry rot causing loss of section	It is recommended that where rot (wet and dry) is present that specialist advice is sought to ensure appropriate remedial action is taken to agree a surface treatment is performed to prevent further section loss	3 Months
3	Dry rot causing loss of section	It is recommended that where rot (wet and dry) is present that specialist advice is sought to ensure appropriate remedial action is taken to agree a surface treatment is performed to prevent further section loss	3 Months
4	Minor spalling and corrosion of concrete base upstand reinforcement	Small concrete patch repair with associated preparation of area to be repaired.	To be monitored

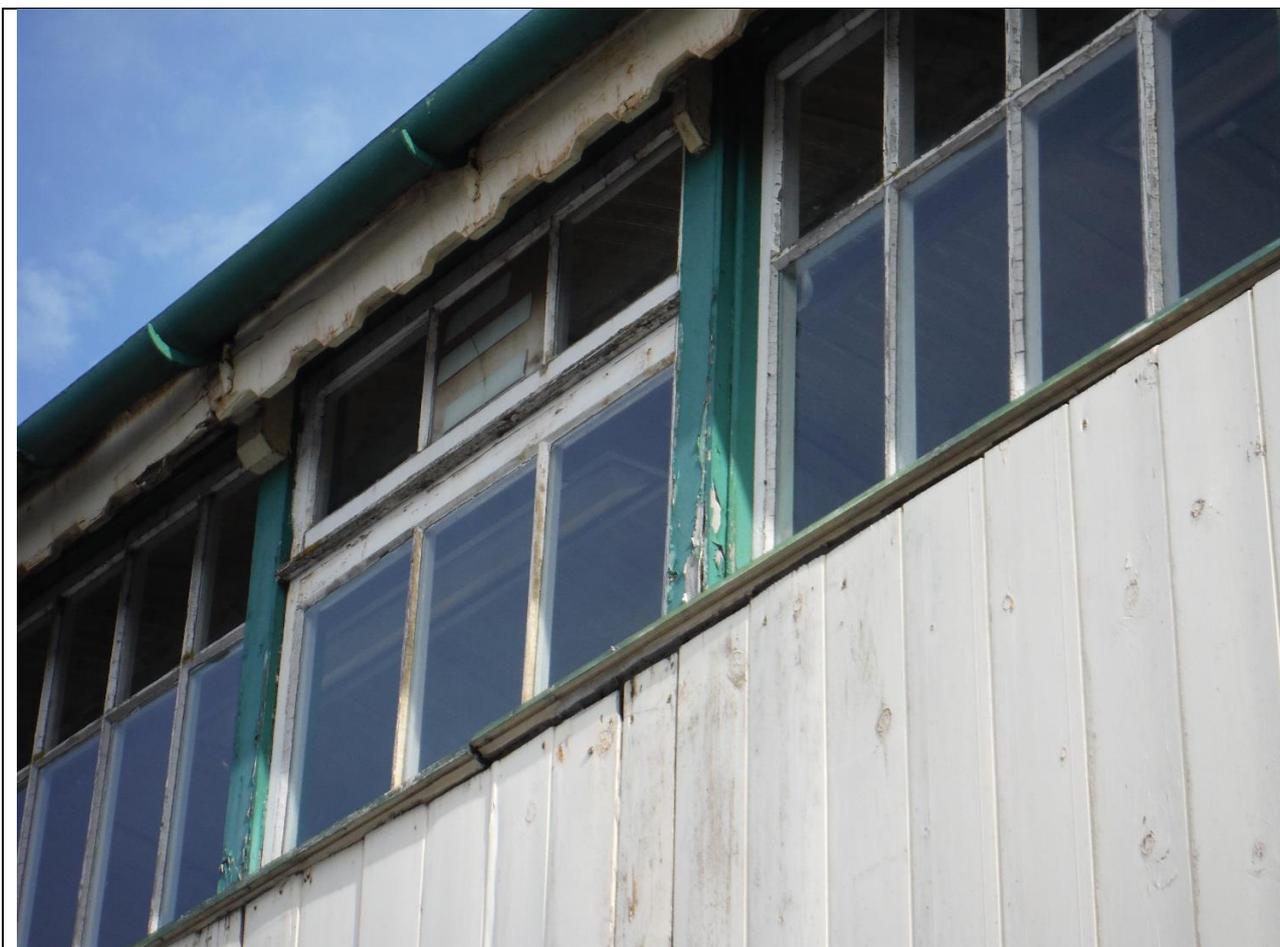
Photo 12: Broken glazing pane in the centre glazing panel above the line. Replacement and repair required

Photo	Defect	Repair	Time frame for action
10	Staining and peeling/loss of paint due to overrunning drainage	Locate source of drainage overrun and take remedial action. Ensure timbers are in good condition, if so re-treat and repaint accordingly.	3 Months
11	Swelling of timber boards due to water ingress	At locations above the platform – repair existing timbers where possible and re-fix to footbridge structure.	6 Months
		At locations above the railway – timber panels are to be monitored during regular inspection – not perceived to be a risk to general public but may cause damage to passing trains.	N/A
12	Broken pane of glass	Replace pane of glass and make good pane mount. All other panes should be checked during future inspections.	3 Months
13	Minor woodworm to stair risers	Treat accordingly to prevent further spread of woodworm	12 Months

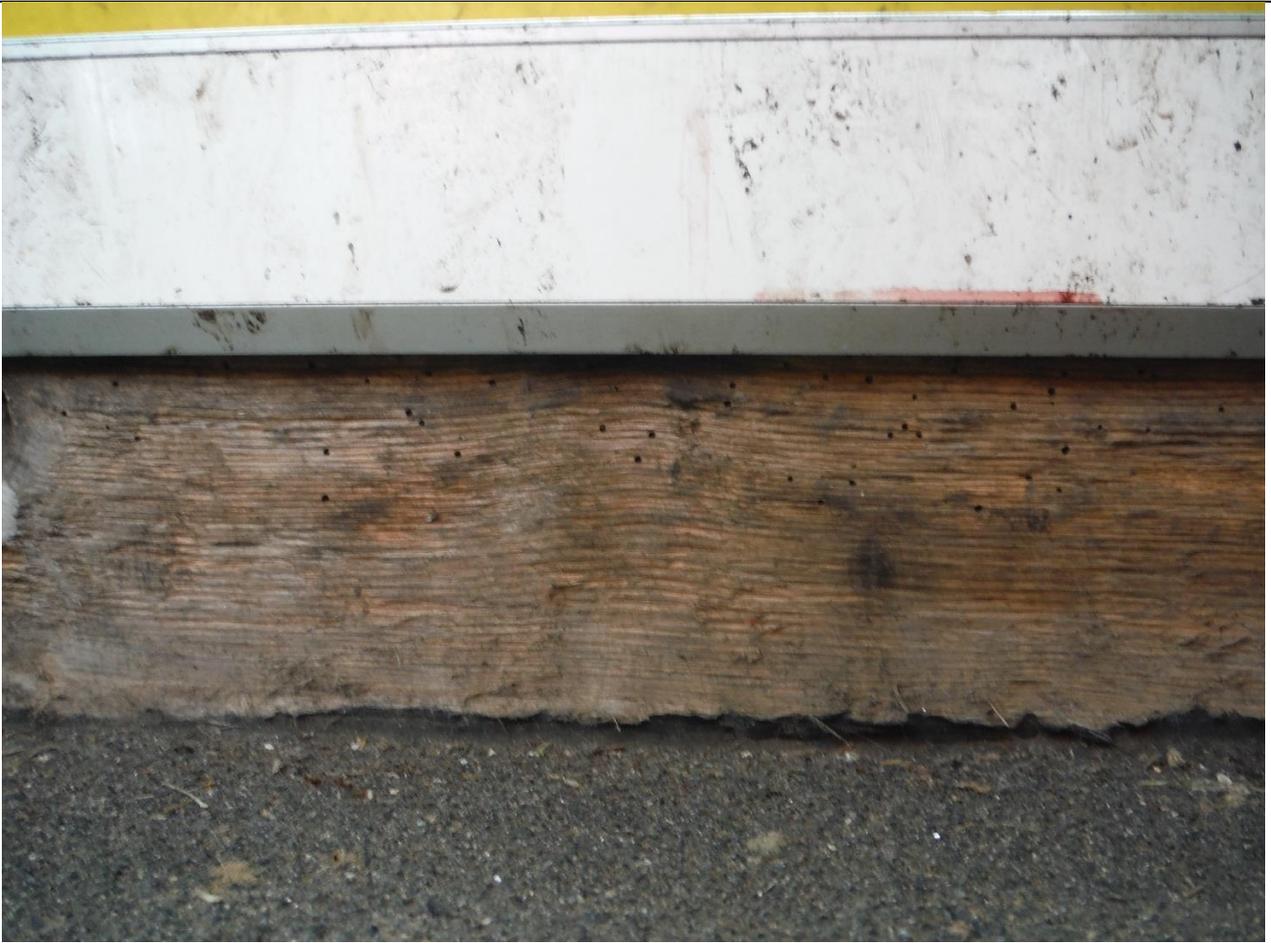
Photo 13: Woodworm affected stair risers (Platform 1)
