# MEMORANDUM

**Date** 17 September 2015  
**Reference** UA007705-19-ECV-MEM-HYD-1503 rev A01  
**From** Richard Shimell  
**To** Ian Grimes, Daniel Perez  
**Copies** Toby Skeels, James Buckley, Tom Faith, Andy Barnes  
**Subject** Alton Station – Heritage Footbridge Condition Report - Addendum

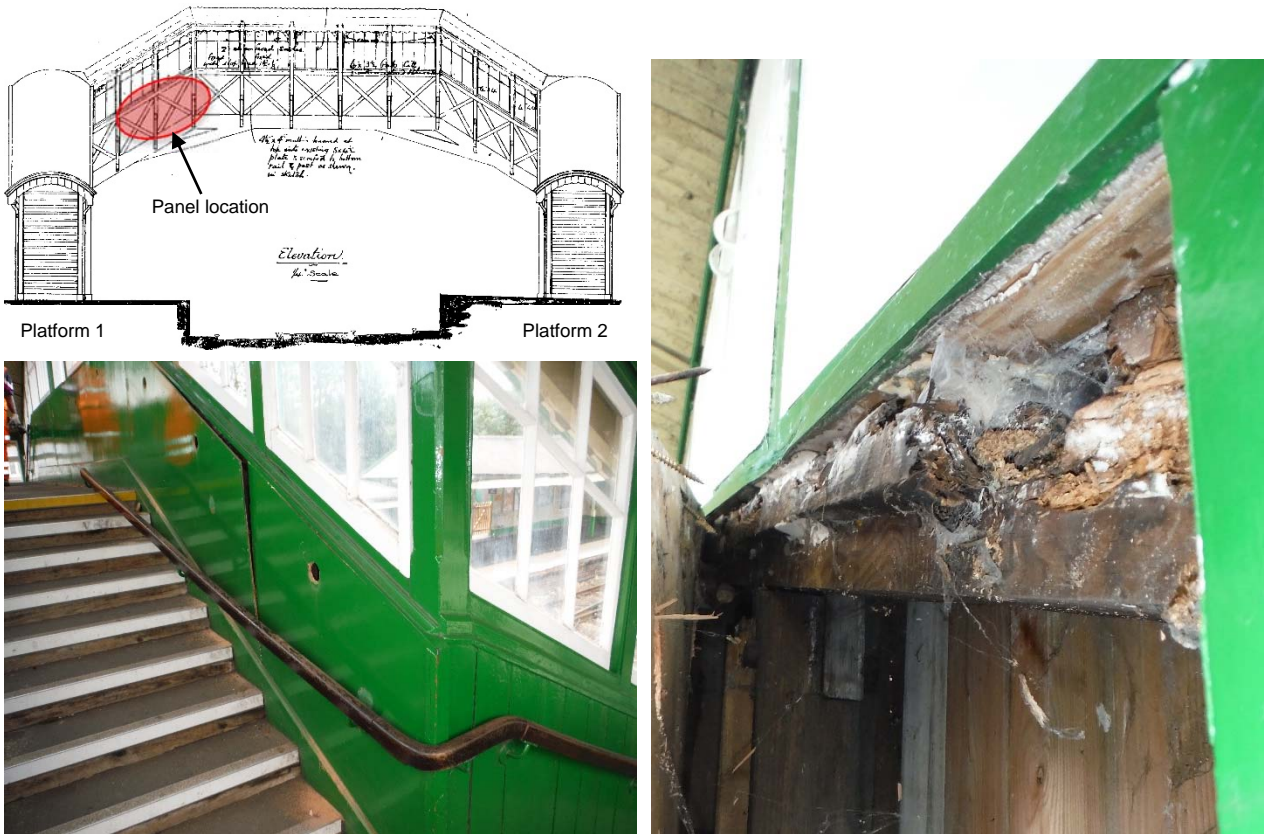
Hyder engineers conducted a daytime site visit on 30 July 2015, principally to look behind the panel Sumo opened adjacent to the Platform 1 stairs. The panel had a significantly rotten timber member, spanning between vertical members beneath the window sill. This location is shown in Figure 1.

Figure 1: Location and rotten timber behind internal panel

1. Previously identified trestle leg repairs should be performed based on extents found in Sumo intrusive survey findings.
2. The rotten timber member beneath the window sill discovered beneath the panel shown in Figure 1 should be replaced.
3. The internal panels which have been drilled for inspection are to be replaced.

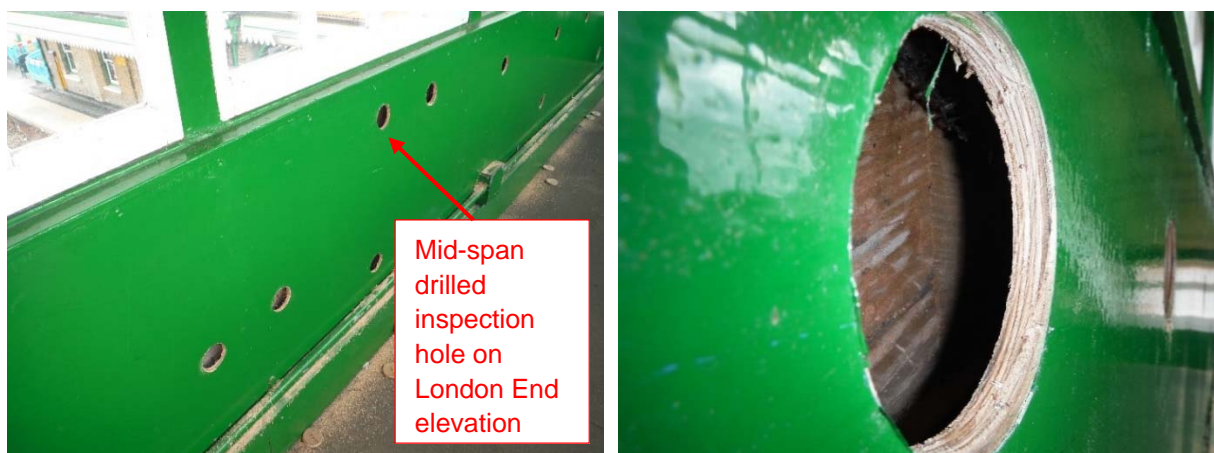
The visual survey continued by looking through the drilled inspection holes on the internal cladding panels to attempt to determine the bridge structure, as initial findings suggested differences to archive information, such as an absence of the cross bracing beneath the windows (as shown in the archive drawing displayed in Figure 1). Whilst the location and size of the holes limited the extent of information to be gained, no cross bracing was observed behind any panel and some structural form could be identified, including perceived main diagonal and horizontal elements, as illustrated in Figure 2 (and shown further in Figure 15).

Figure 2: Drilled inspection hole showing diagonal member transition into horizontal member

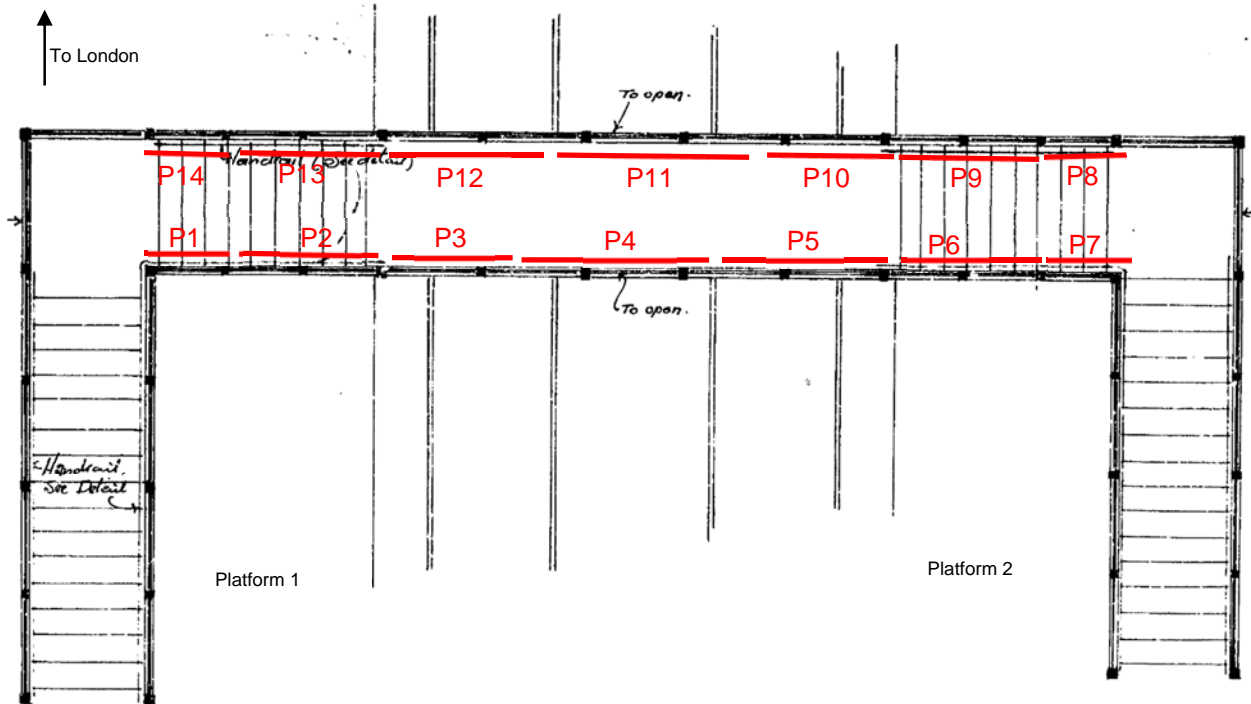
Figure 3: Internal panels numbering for video survey

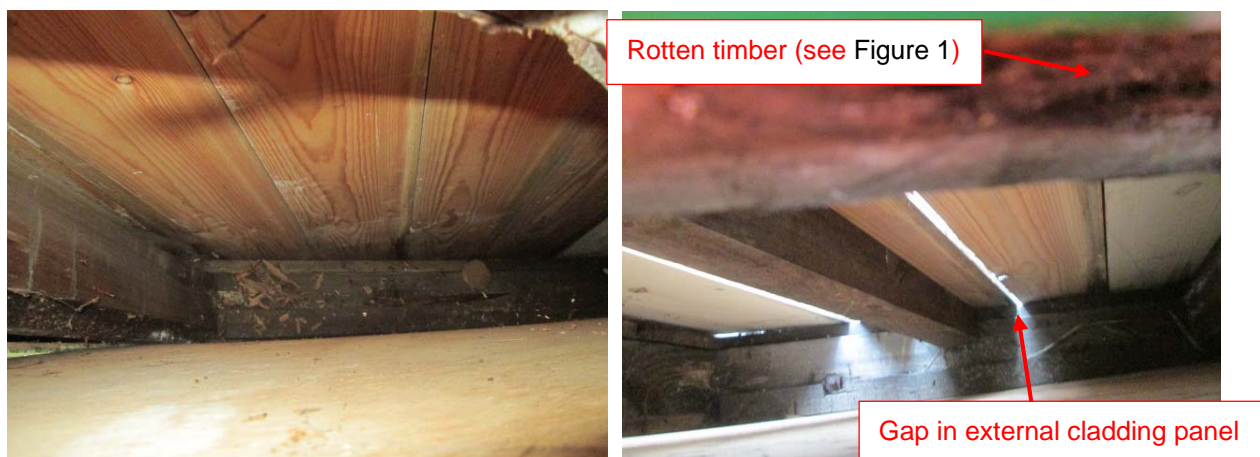
Figure 4: View down into Panel 1 and view down into Panel 2

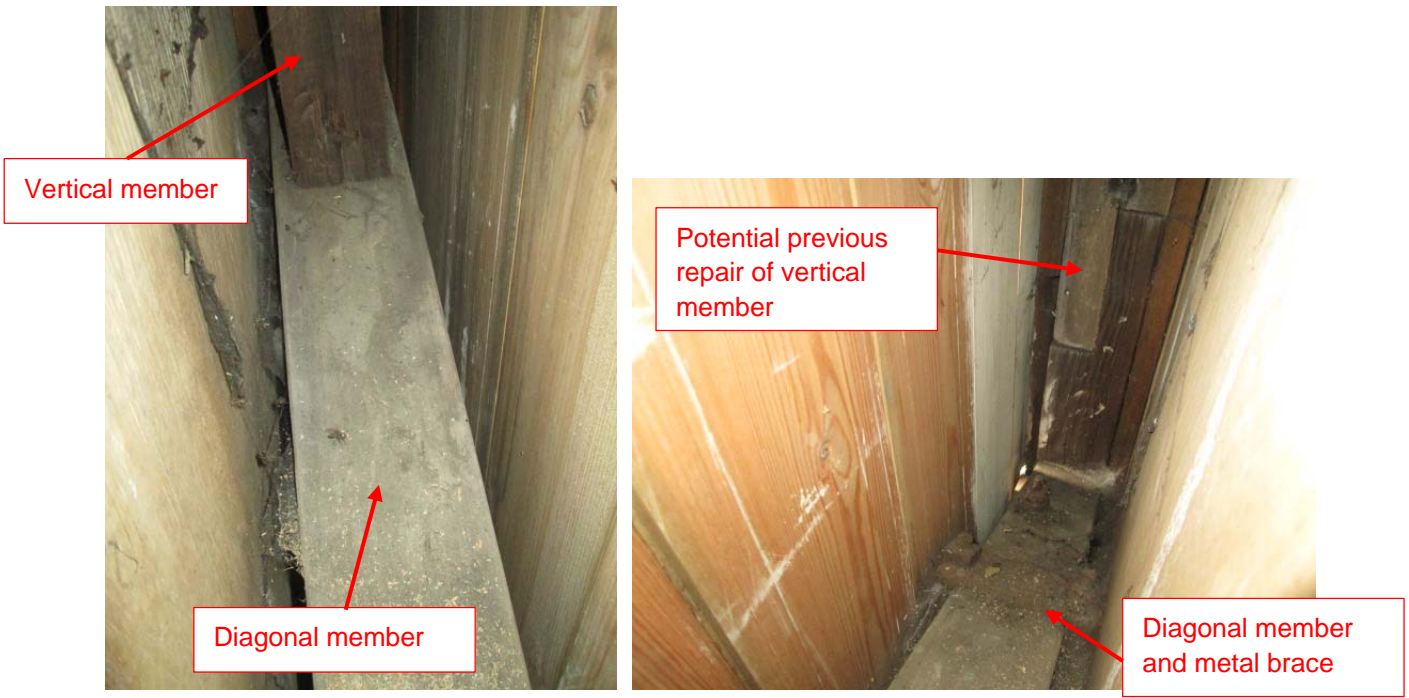
Figure 5: View towards Platform 2 and view towards Platform 1 in Panel 3

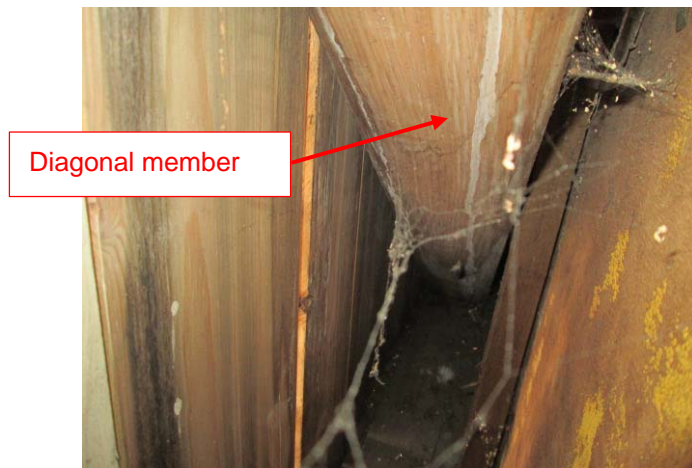
Figure 6: View towards Platform 1 in Panel 4

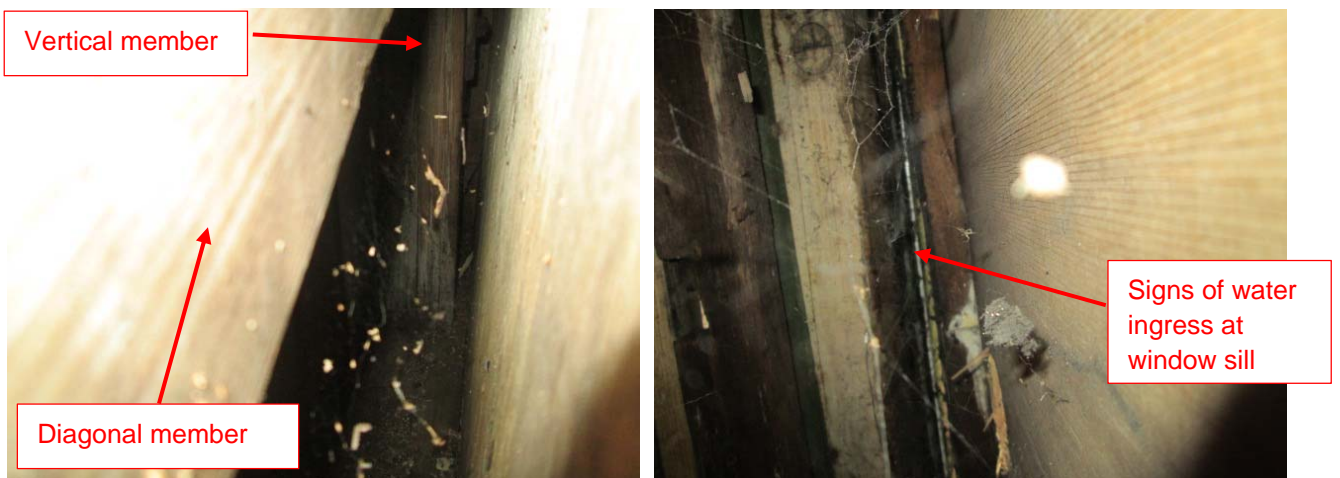
Figure 7: View towards Platform 1 and a view looking up to the window sill in Panel 5

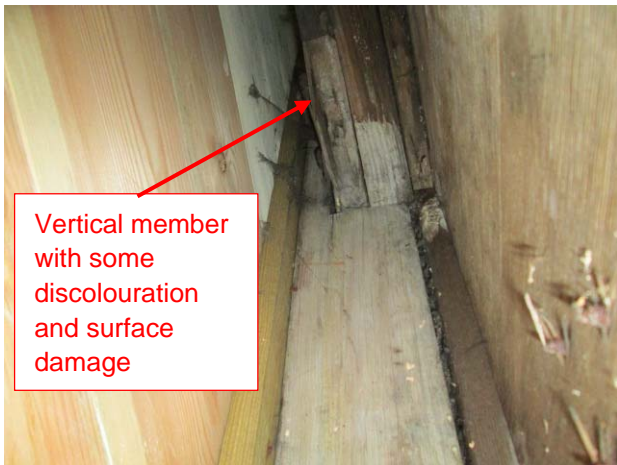
Figure 8: View towards Platform 1 in Panel 6 and a view towards Platform 1 in Panel 7

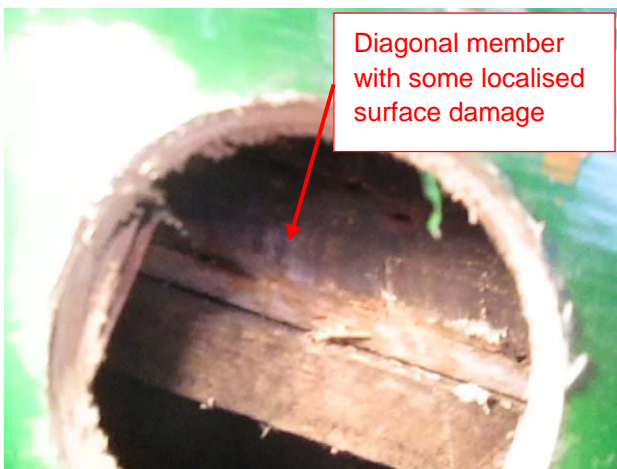
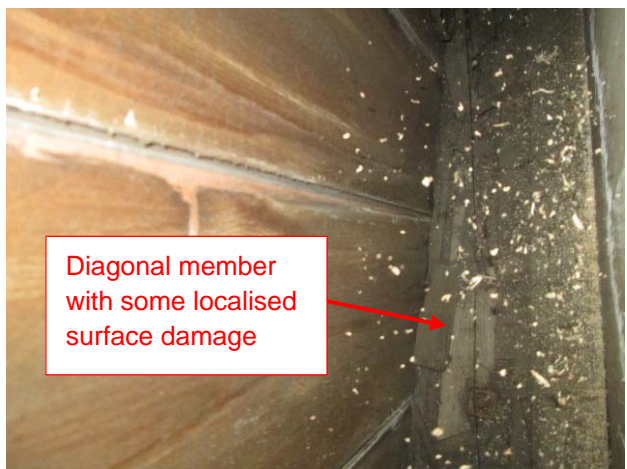
Figure 9: View through inspection hole at top of Panel 8 and a view down into Panel 8

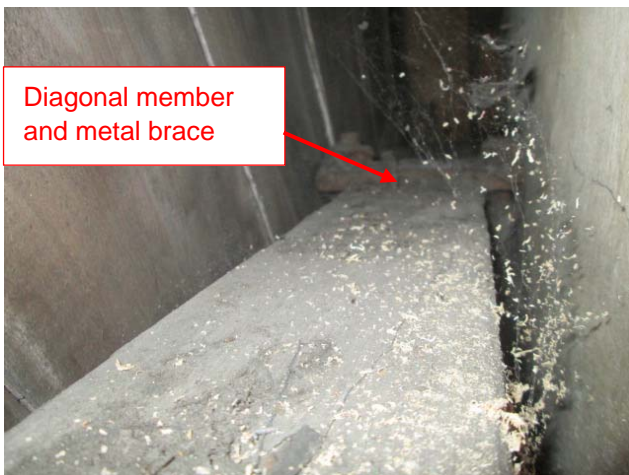
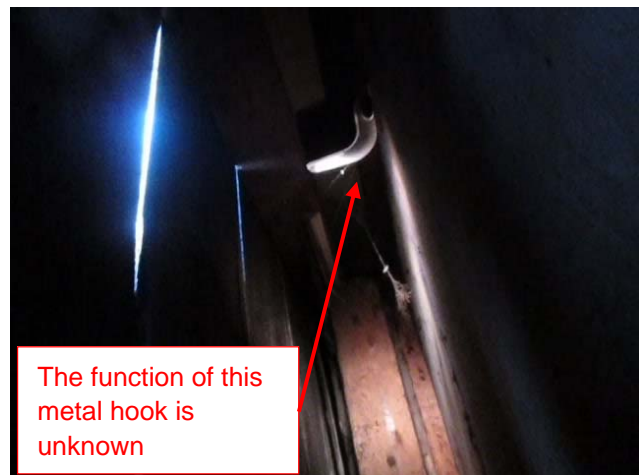
Figure 10: View looking down towards Platform 2 and a view looking up towards Platform 2 in Panel 10

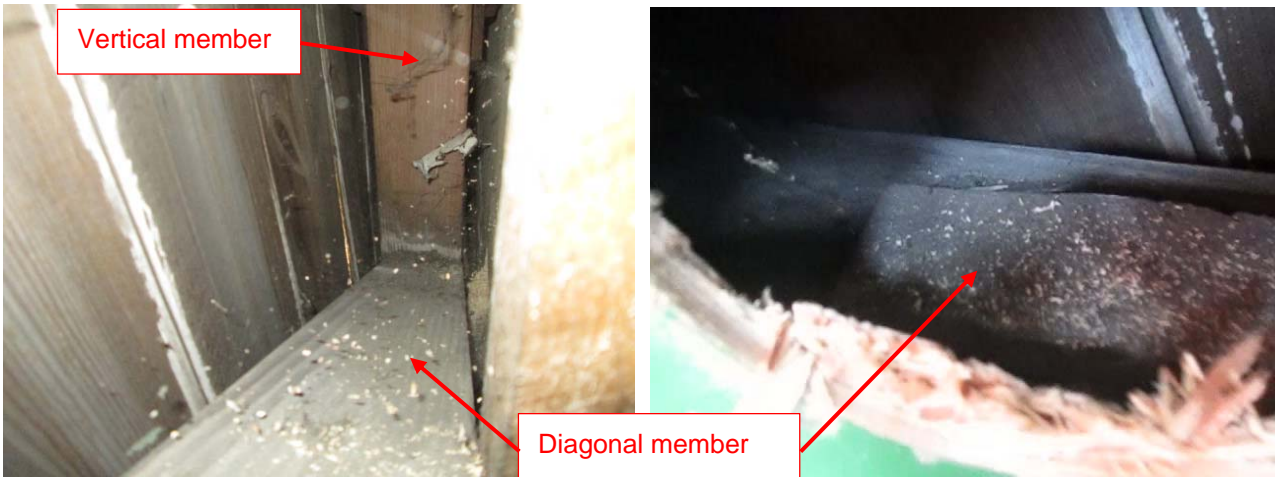
Figure 11: View towards Platform 2 and a view down in Panel 11

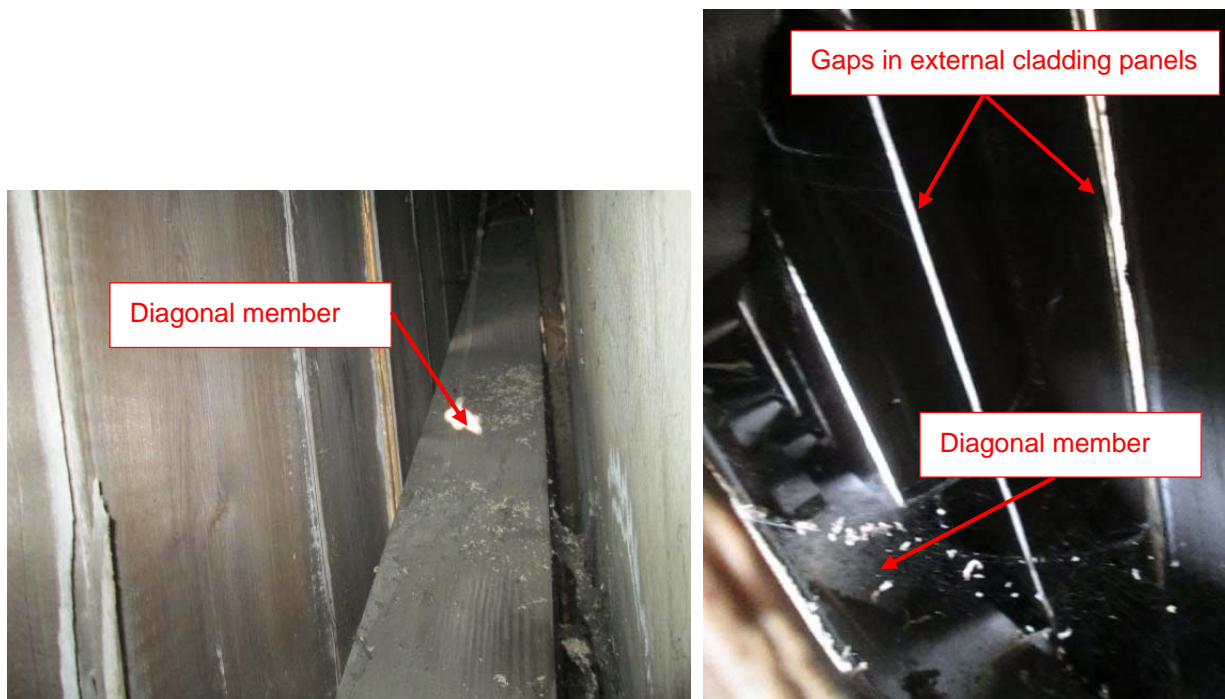
Figure 12: External views of Panel 12

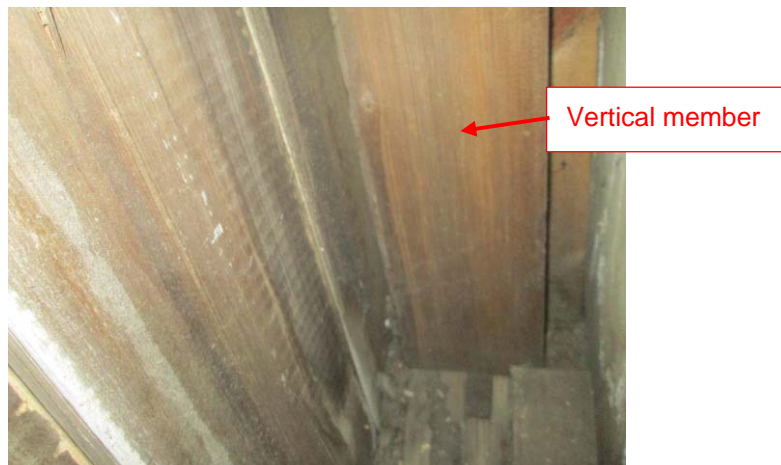
Figure 13: View in Panel 13 & 14 (staircase)

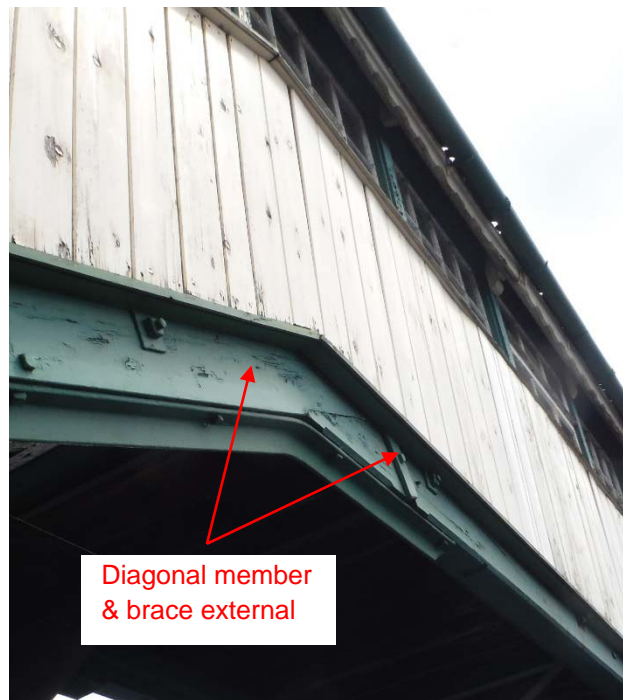
The video and photographic evidence provided shows the diagonal members (transverse stair stringers) spanning from the support trestles do not form the bottom chord of the footbridge. These diagonal members continue up into the structure and another member spans horizontally across the tracks. This supports external observations and suggests metal bracing has been used to provide a link between these two structural members.

Figure 14: View from Platform 1 of external main span diagonal member which continues under the stairs up between the internal panels and external cladding. A metal brace appears to pass above this diagonal member, as shown in Figure 5 and Figure 10 and fix externally into the main horizontal member

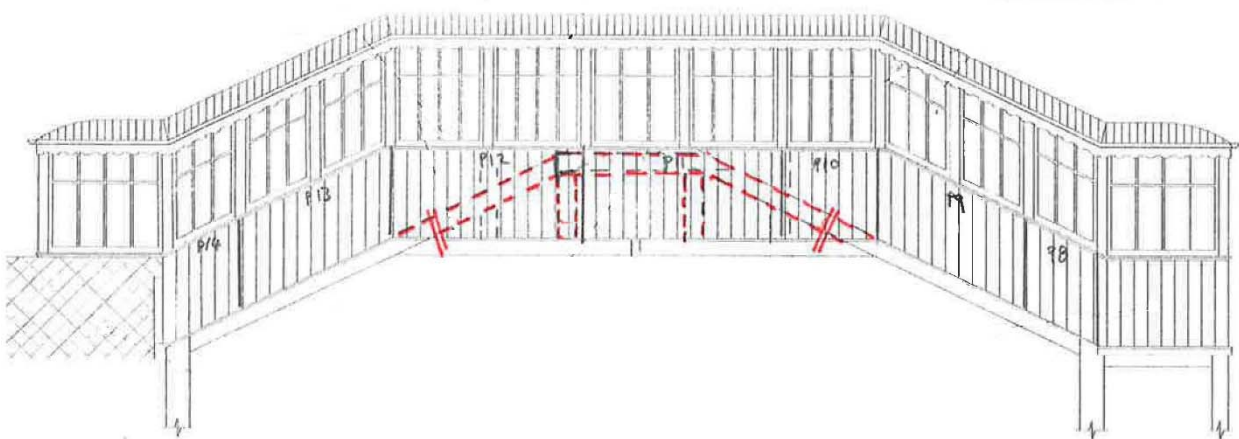
Figure 15: Believed structural form of Alton Footbridge from photos and video evidence
